135th St and Ridgeland Ave <Westbound>

Palos Heights, IL RLR 1 Year Follow-Up Evaluation Report

Reference No: 016-67857

November 2019

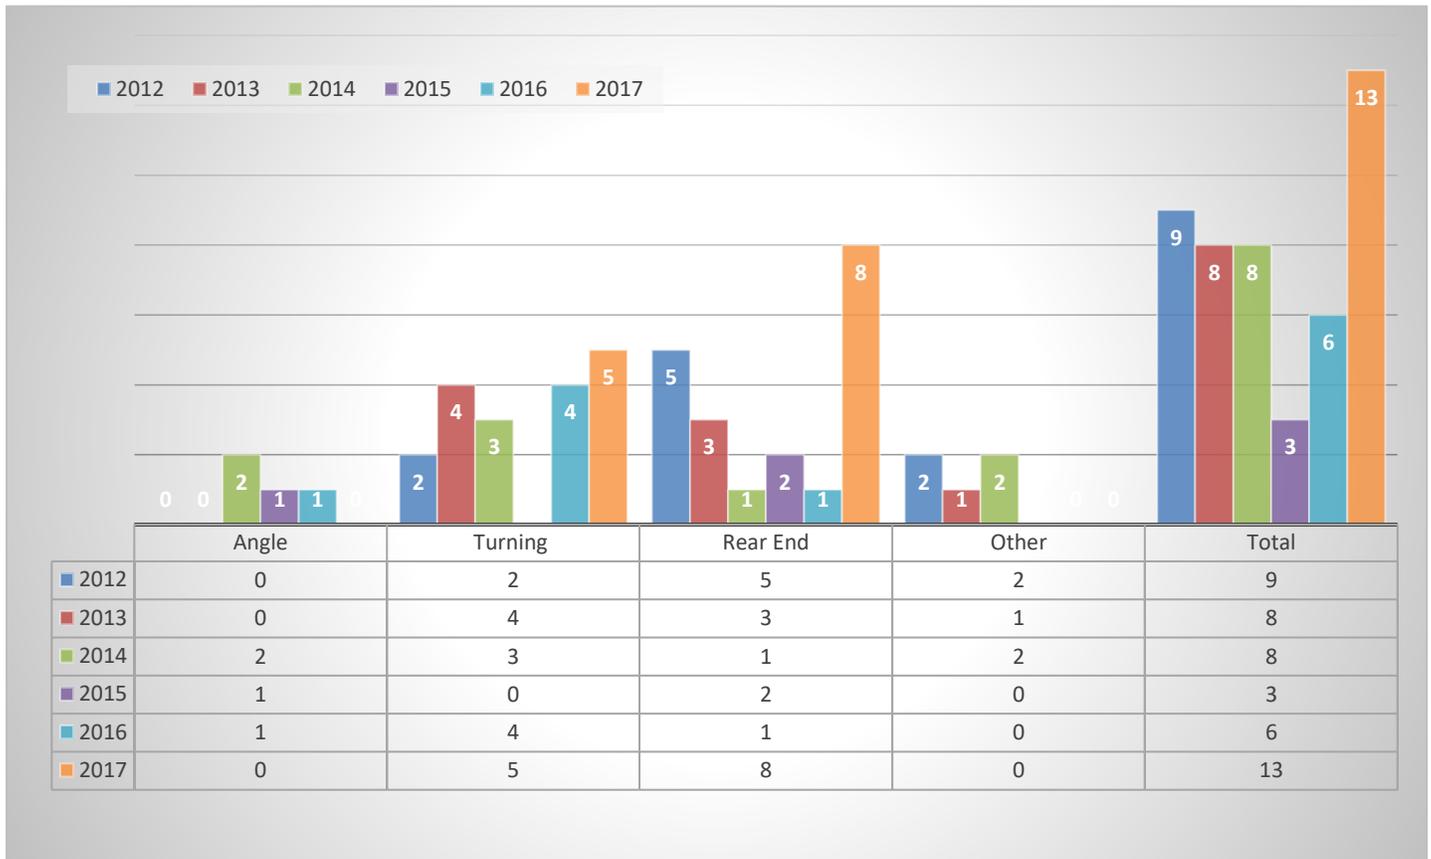
The chart below shows the trends of each crash type from 2012–2017.

From 2012-2015, prior to the RLR camera vendor transfer, there were 28 total crashes; this averages out to 7 total crashes a year. In 2017, post RLR camera vendor transfer, there were 13 total crashes.

From 2012-2015, prior to the RLR camera vendor transfer, there were 11 rear end crashes; this averages out to 2.75 rear end crashes a year. In 2017, post RLR camera vendor transfer, there were 8 rear end crashes.

From 2014-2015, prior to the RLR camera vendor transfer, there were 2 angle crashes in 2014 and 1 in 2015. In 2017, post RLR camera vendor transfer, the angle crashes went down to 0.

From 2012-2015, prior to the RLR camera vendor transfer, there were 28 total crashes; this averages out to 7 total crashes a year. In 2017, post RLR camera vendor transfer, there were 13 total crashes. From 2012-2015, there were 11 rear end crashes; this averages out to 2.75 rear end crashes a year. In 2017, there were 8 rear end crashes. From 2014-2015, there were 2 angle crashes in 2014 and 1 in 2015. In 2017, the angle crashes went down to 0. (See Tab 2)

Studies have reported that RLR cameras generally reduce severe Angle crashes with an occasional increase in less-severe Rear End crashes. This intersection showed a similar trend in its first year of transfer, though it is very difficult to determine the effectiveness of the RLR cameras currently installed at this intersection at this time. A larger sample size of data is required to reach a more accurate conclusion.

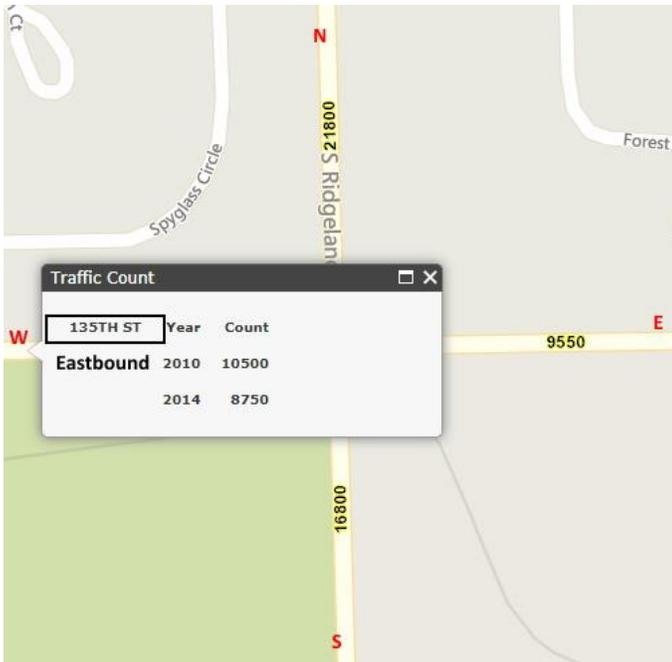
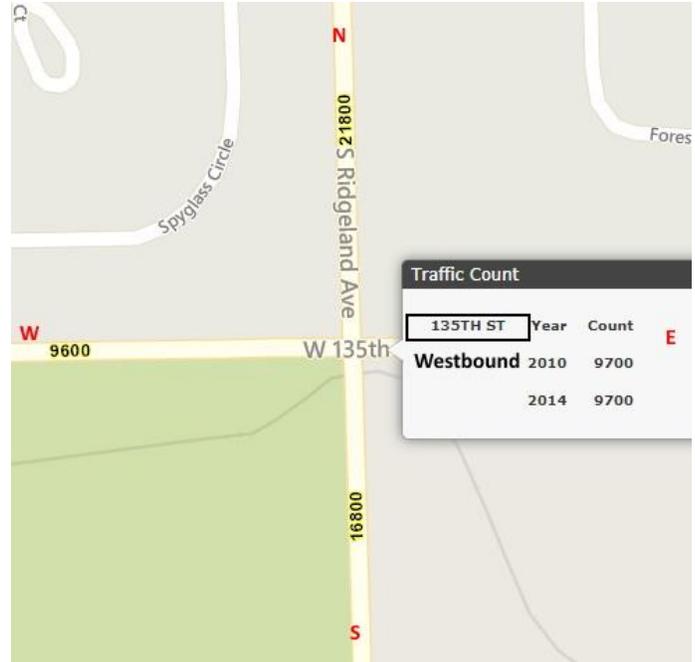
Eastbound and Westbound ADTC

The following page consists of screenshots of ADTC data from 2012-2017 obtained from the IDOT's website.
