IL Rt. 43 (Harlem Ave) and IL Rt. 83 (College Dr)

Palos Heights, IL RLR 1 Year Follow-Up Evaluation Report

Reference No: 016-61661

November 2019

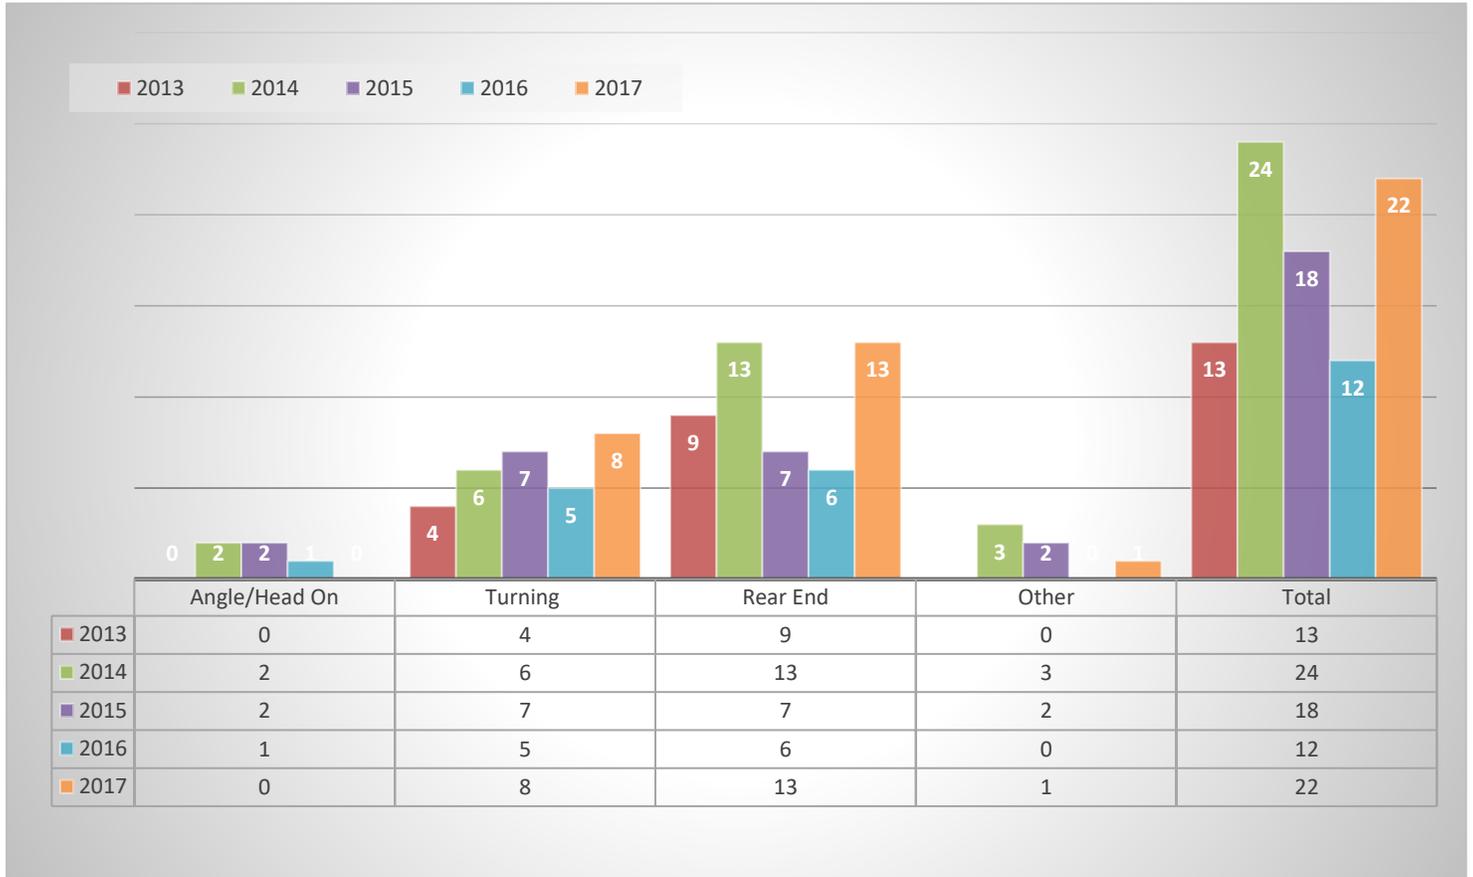
The chart below shows the trends of each crash type from 2013–2017.

From 2013-2015, prior to the RLR camera vendor transfer, there were 55 total crashes; this averages out to 18.33 total crashes a year. In 2017, post RLR camera vendor transfer, there were 22 total crashes.

From 2013-2015, prior to the RLR camera vendor transfer, there were 29 rear end crashes; this averages out to 9.67 rear end crashes a year. In 2017, post RLR camera vendor transfer, there were 13 rear end crashes.

From 2014-2015, prior to the RLR camera vendor transfer, there were 2 angle crashes in 2014 and 2 in 2015. In 2017, post RLR camera vendor transfer, the angle crashes went down to 0.

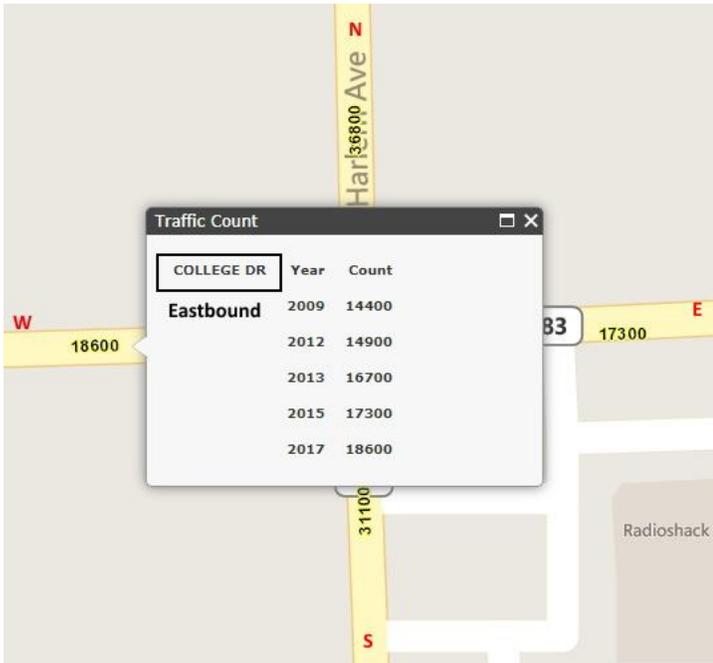
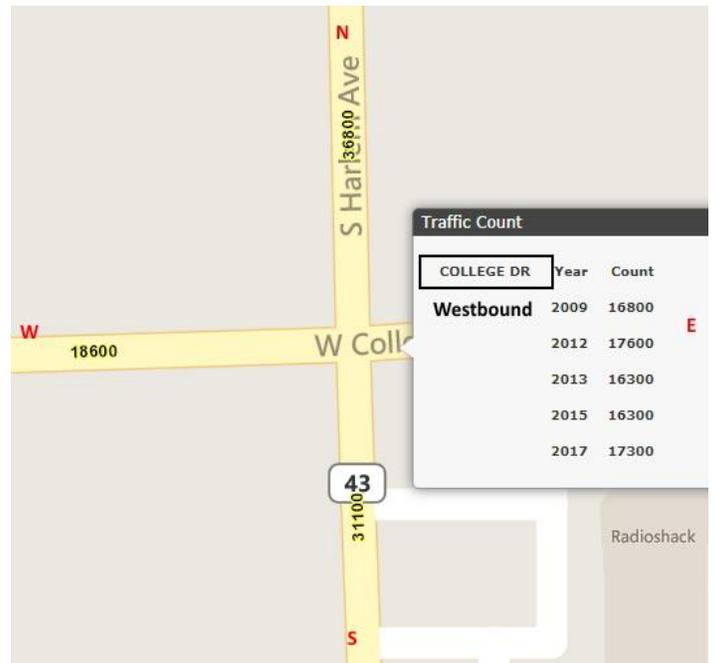
Eastbound and Westbound ADTC

The following page consists of screenshots of ADTC data from 2013-2017 obtained from the IDOT's website.
